STARTER SWITCH CHANGE

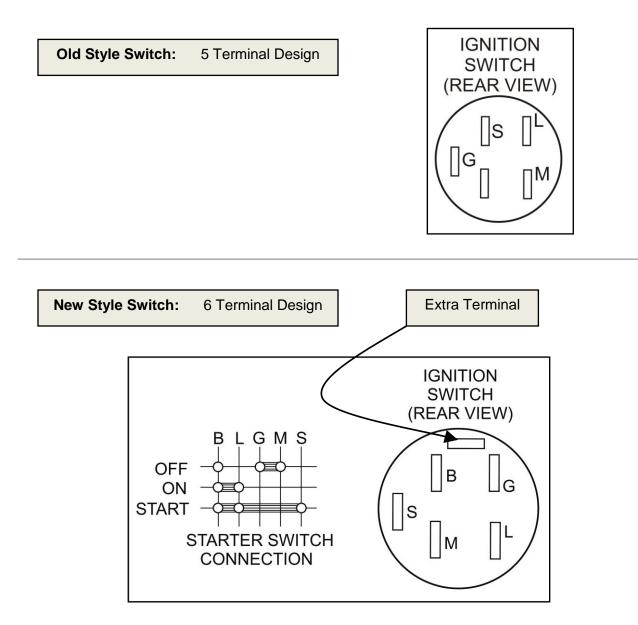
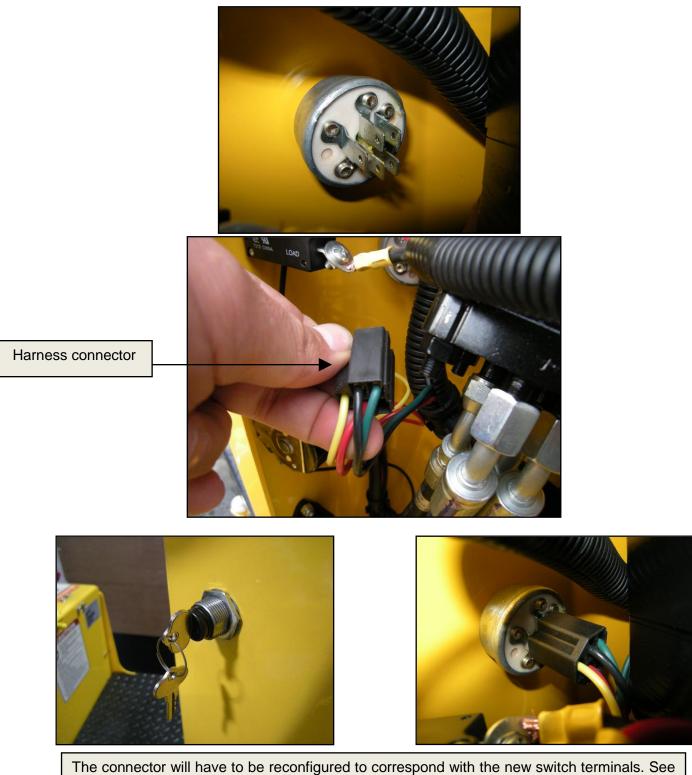
The starter switch has been changed from a 5 terminal switch to a 6 terminal switch. The part number remains the same. The new switch has an extra terminal which is not used. It will require the technician to reconfigure the harness connector to match the new terminal positions. The extra terminal should be removed.

page one, terminal configuration is different between old switch and new switch.
