SERVICE BULLETIN

Fuel Suction Tube

Up to Serial Number 250115 (January, 2005)

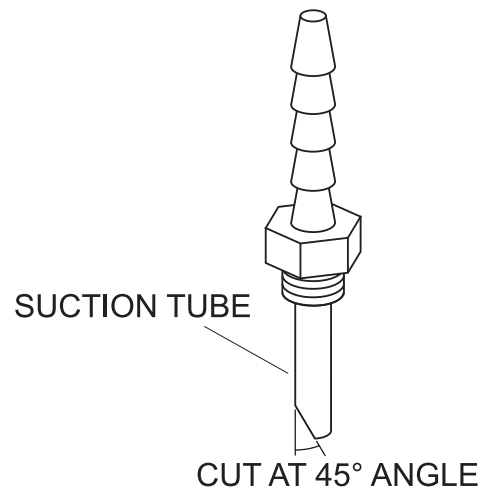
Figure 1. Suction Tube

The Nissan engine will not stay running. This may cause fuel pump to overheat.

It was discovered that during hot weather, the poly fuel tank will slightly warp causing the tank bottom to touch the fuel suction tube. This restricts the fuel flow to the pump thus starving the engine.

1. Disconnect the fuel hose from the barb fitting located on the fuel suction tube.
2. Using a 9/16-inch deep socket, remove the suction tube from the tank.
3. Modify the tube by cutting a 45° angle cut. See Figure 1.
4. Make sure that the angle cut is not left sharp. A sharp cut will eventually wear a hole in the tank.
5. Place the modified suction tube back into the fuel tank and reconnect the fuel hose to the barb fitting.
