## VACUUM PUMP WIRING COUNTERMEASURE

# Technical Information

Product Group: GENERATORS

Model: DCA125SSIU4F

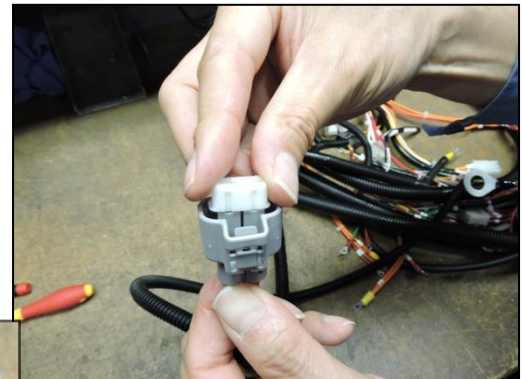
9. Wire installed correctly
