4LE2 LIGHT LOAD EGR VALVE SOOT DEPOSITS

Technical Information

Product Group: DCA-SERIES
Model: DCA20-45 & DIS185SSI4F

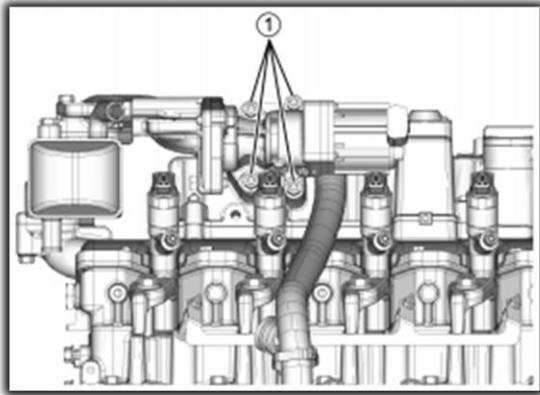
The Isuzu 4LE2 Tier 4 Final engine may experience heavy Unburnt Fuel (**Soot**) deposits in the Exhaust Gas Recirculation (**EGR**) Valve due to Light Loading situations, thus causing the specific EGR flash codes 44 (P0409) or 45 (P0404).

1. Remove the valve to clean off the deposits, (one electrical plug and 7 bolts), (Note: Gaskets can be reused), Ref. Fig. 1 & 2.
2. Remove unwanted deposits using a flat blade screwdriver. Once deposits have been cleared, confirm the spool moves freely.
3. These EGR faults will self-clear at the next power (operator key or toggle switch) cycle. No code clearing via IDST or jumping V53, unless other codes are active.
