## ECU845 UNREADABLE SCREEN, CONTRAST ADJUSTMENT AND FIRMWARE UPDATE

DCA70SSIU4F DCA125SSIU4F DCA180SSJU4F3 DCA300SSJU4F3 DCA600SSV4F3  
DCA70SSJU4F DCA150SSJU4F3 DCA220SSJU4F3 DCA400SSI4F3

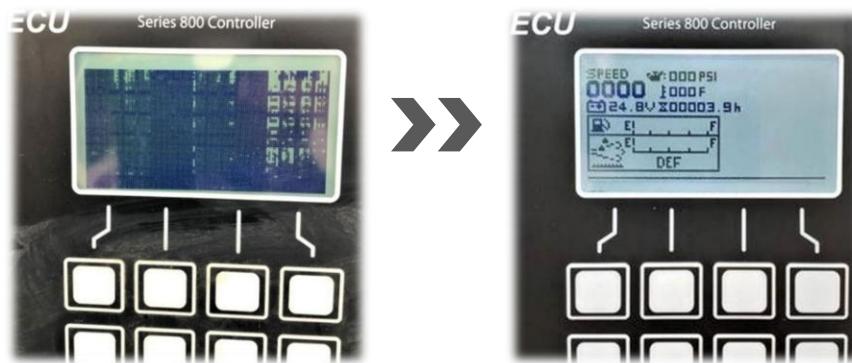
Some ECU845 controllers may present with a partially unreadable display screen due to exposure to extreme weather condition. The occurrences of dark screens can be resolved by the following...

**Step 1:** Making a Display Contrast Adjustment in the controller settings to make the screen more readable.

**Step 2:** Updating the controller Firmware.
