## HATZ ENGINE EGR DTC CORRECTIVE ACTION

### SPN 2791 FMI xxx

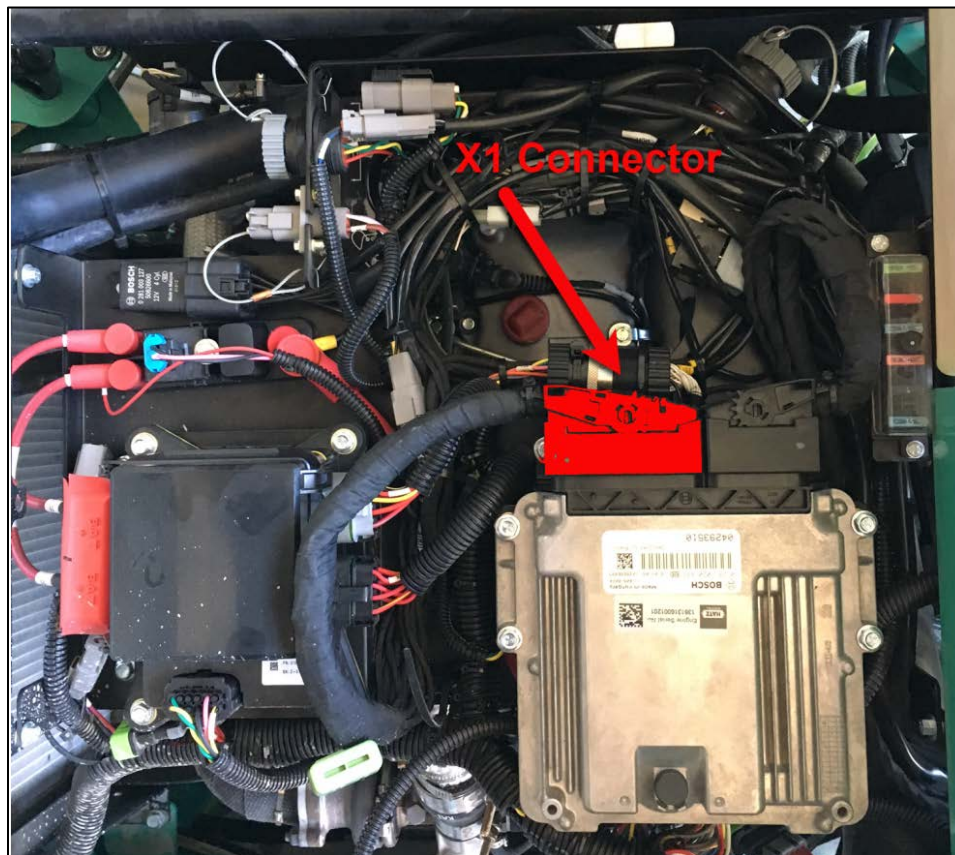
1. Locate APP wire bundle in the Hatz engine harness coming off the X1 connector. The APP wire bundle should be terminated 12 to 14 inches from the X1 connector.

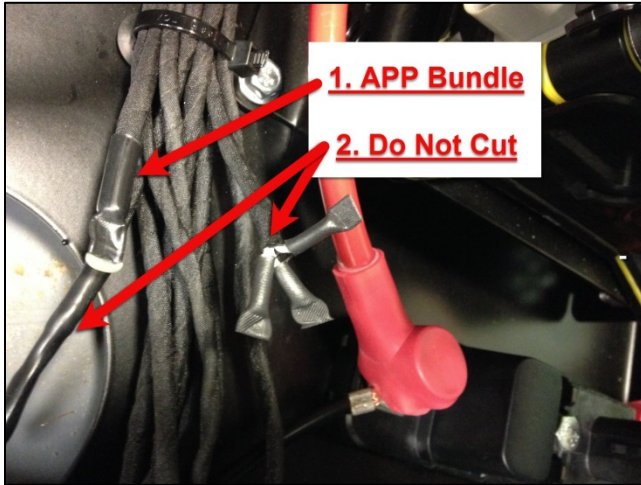
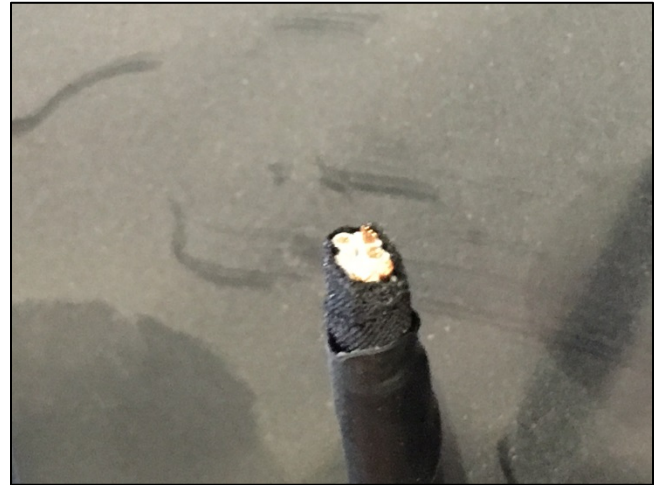
2. Once located, remove the factory shrink tube and expose the (6) flush cut wires. Smaller diameter 3 wire bundles should be left as is.
