Service Bulletin

MTX60 Fuel Cap Inspection

Product Group: Rammers	Date Issued: 04/01/11	Service Bulletin No. RT20110401
Bulletin Type <input checked="" type="checkbox"/> Mandatory <input type="checkbox"/> Information Only <input type="checkbox"/> Recommended Change		Models/Series Affected: S/N V-6045 – V-6088, V-6093 – V-6098, V-6105 – V-6112, V-6129 – V-6132, V-6173 – V-6331

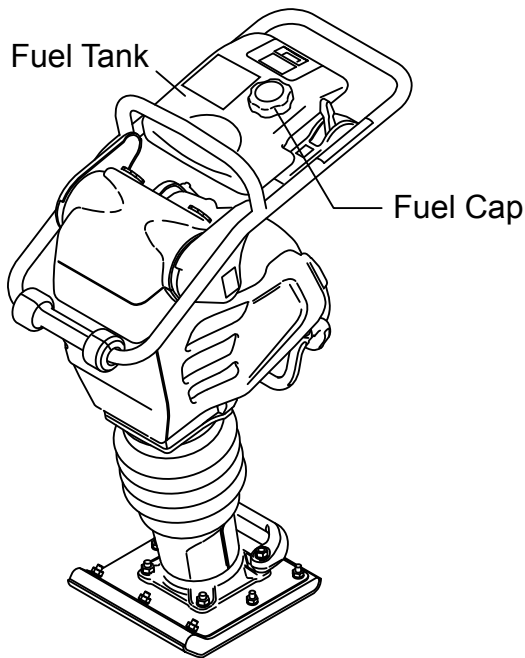
Figure 1. Remove Fuel Cap

1. Remove the fuel cap from the fuel tank (Figure 1).

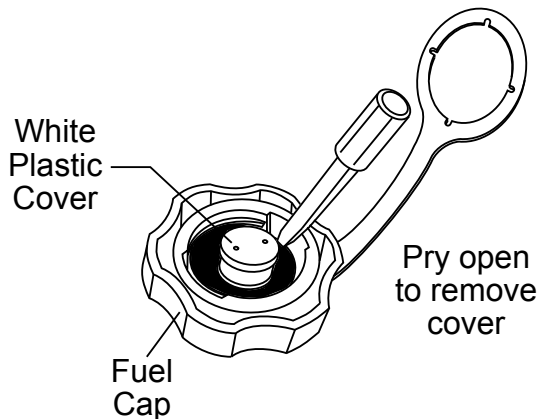
Figure 2. Remove Plastic Cover

2. Use a flat blade screwdriver to remove the plastic cover from the inside of the cap (Figure 2).

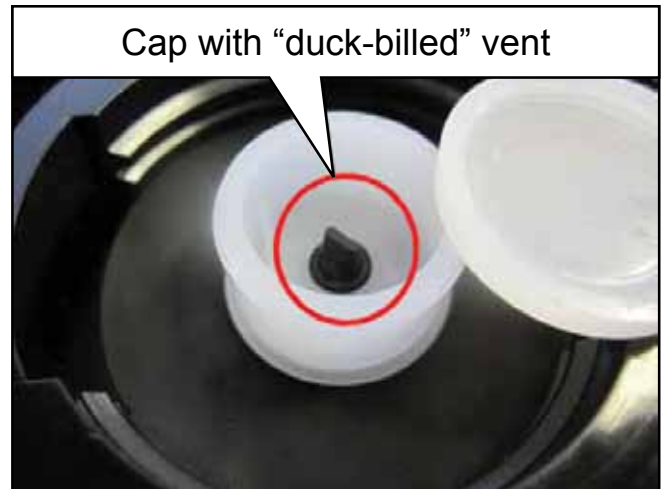
3. If the inside of the cap has a rubber “duck-bill” vent (Figure 3), no further action is required.

Figure 3. Cap with “Duck-Billed” Vent

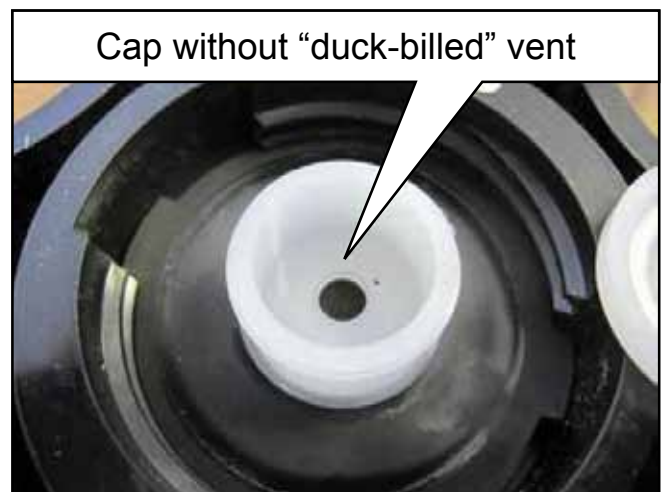
Figure 4. Cap without “Duck-Billed” Vent

4. If the inside of the cap **DOES NOT** have a rubber “duck-bill” vent (Figure 4), order the correct cap (P/N 366900020) from the Multiquip parts department.
