## ENGINE FLYWHEEL KEY SHEARING

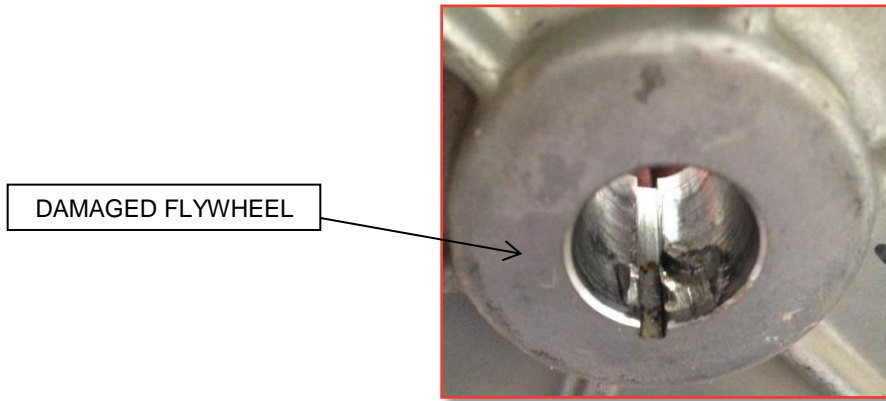
It has been documented; some flywheel keys shearing on the ER12 engine used on the MTX70SD and MTX80SD rammers. The engine manufacturer was informed of this situation and made corrective actions since.

Preventive measure can be taken by inspecting the torque value of the flywheel nut.

(Torque specification **44-50 ft.-lbs.**)

Inspect the taper of the crankshaft for damage prior to replacing the flywheel. Before reassembly, clean the tapered areas of the new flywheel and crankshaft.
