EXCITER VENT OIL CONTAMINATION

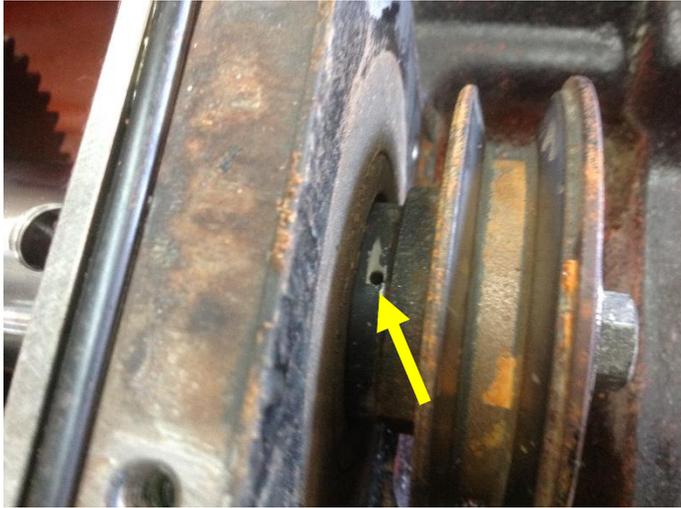
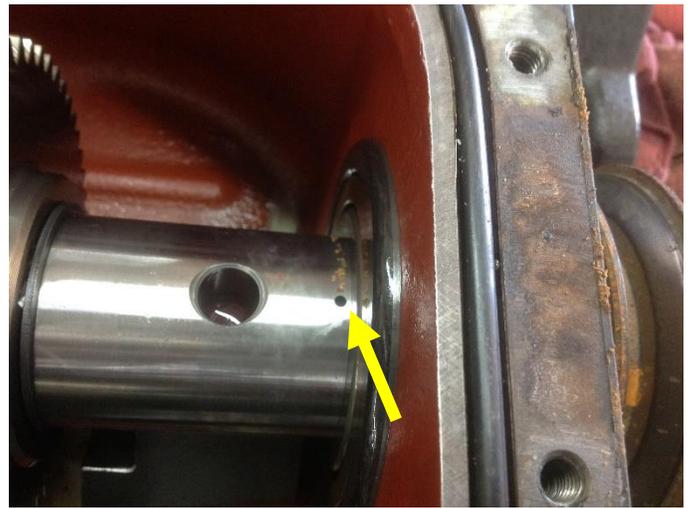
External vent hole in the solid shaft is located behind the driven pulley and is located on top of the shaft. The pulley and belt is inside the belt guard and is protected from debris, but not water level that rises above the vent hole and cools the exciter, this draws water into the housing. The vent hole inside the exciter housing, located in the solid shaft, allows air to enter to equalize the internal and external air pressure when the plate is shutdown.

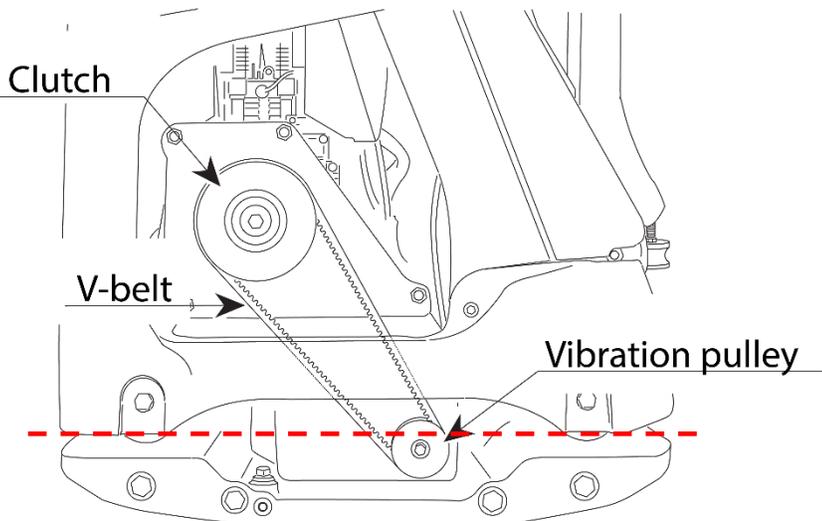
Water level that rises to the level of the red dotted line will be above the vent hole behind the pulley in the solid shaft and water can be drawn into the exciter.

NOTE: When the plate returns from rental, part of the check-in should be, to check the exciter lubrication for signs of contamination. If found milky with water contamination, clean and flush the housing and refill with clean fresh 30W oil to the proper oil level. If in doubt, operate the unit till hot and change the oil again. If this procedure is performed soon enough and the unit has no visible performance issue after operating for a while, the unit can be placed back into service.
