IMPORTANT PRODUCT UPDATE

Date: 02/22/21
To: DCA20SPXU4F, DCA25SSIU4F, DCA36SPXU4F and
DCA45SSIU4F Owners
From: Multiquip Product Department
Subject: Control Panel Warning Lamp — **ACTION REQUIRED**

Service Bulletin

Generator Warning Lamp Countermeasures

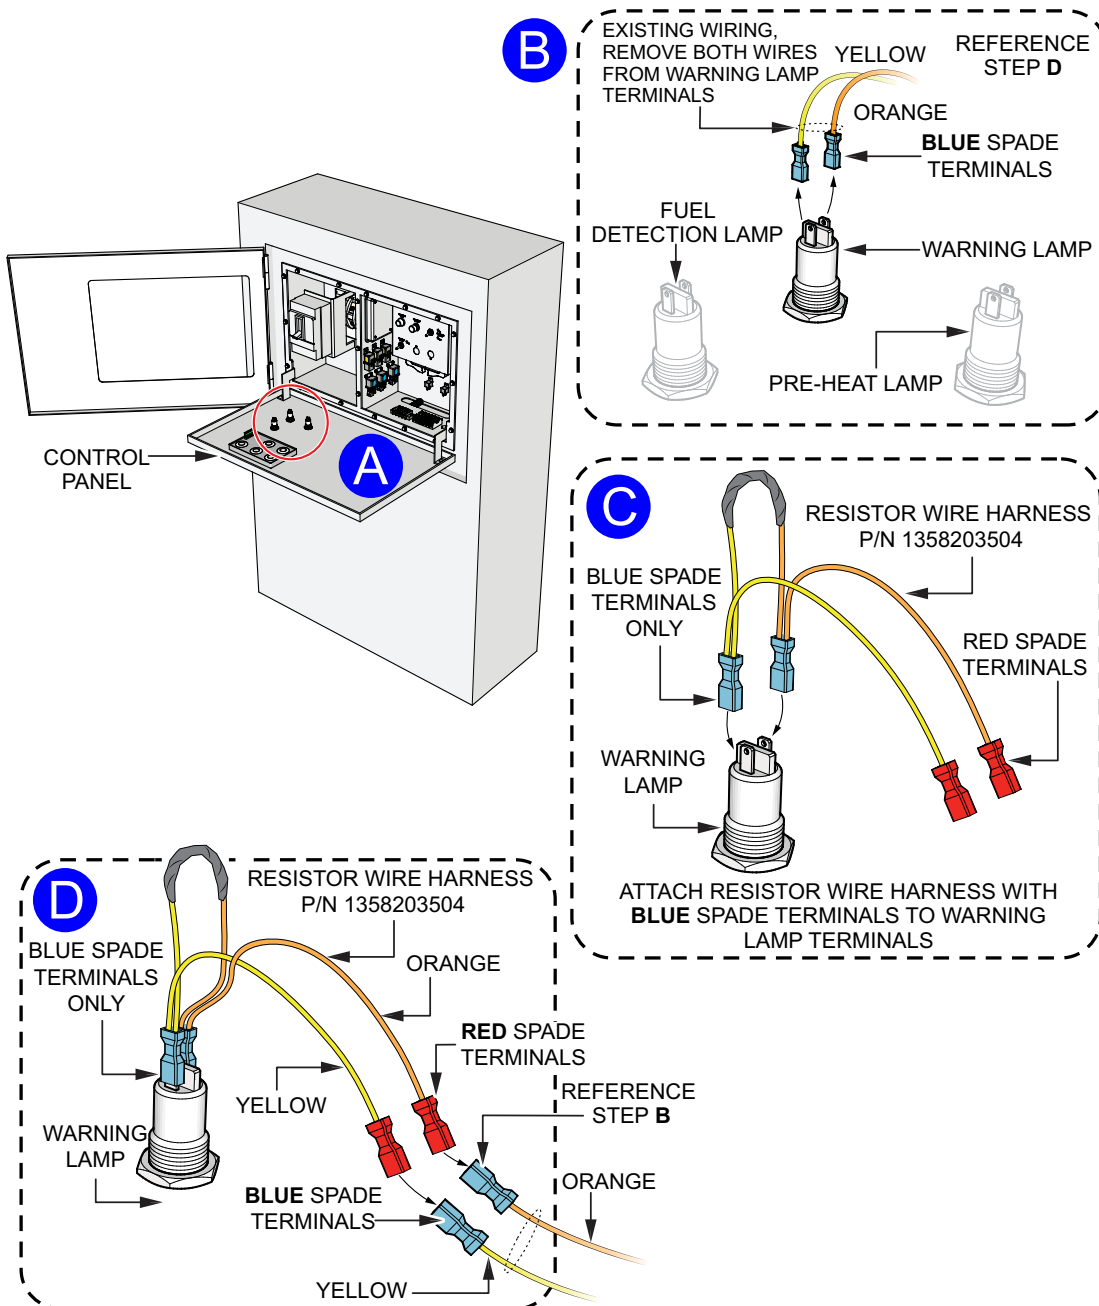
Figure 2. Installation Procedure

Problem:
Some generators are experiencing a warning lamp appearing to be "ON" or dimly lit under low light conditions. This gives the operator an improper FAULT reading. To correct this problem we are requesting the following corrective action.

Before proceeding, visually inspect generator and verify if **Resistor Wire Harness** is already installed. Reference Figure 2D. If wire harness is installed, no further action is required.

1. Loosen thumb screws securing control panel to the generator frame.
2. Lower control panel (Figure 2A) to access wiring connections.

3. Remove the two wires attached to the Warning Lamp (**BLUE** terminals) as shown in Figure 2B.
4. Next, attach the two wires with **BLUE** spade terminals from Resistor Wire Harness (P/N M1358203504) to the Warning Lamp terminals as shown in Figure 2C.
5. As referenced in Figure 2D, attach the two wires with **RED** spade terminals from Resistor Wire Harness to the two wires with **BLUE** spade terminals that were removed in Figure 2B. Be sure to **match** the wire colors.

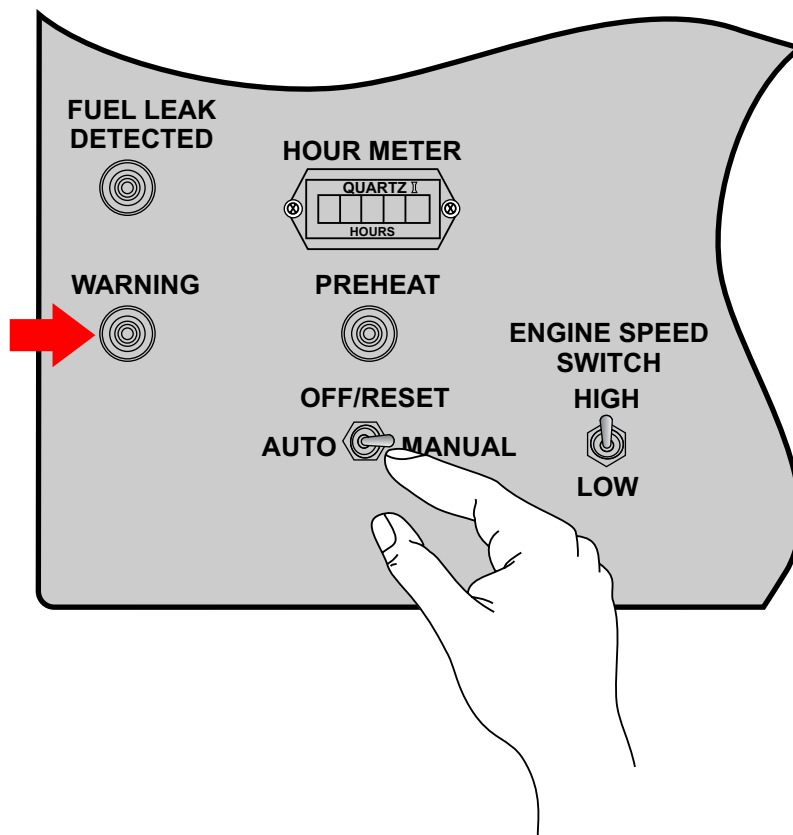
Figure 3. Generator Control Panel (Warning Lamp)

If the warning lamp remains lit after 3 seconds, insure no faults are present. If a fault is present, that fault must be cleared before the warning lamp will turn off. Consult your Operations manual for further steps on clearing faults or contact **Multiquip's Technical Support Team @ 1-800-421-1244 for additional assistance.**

1. With the engine **OFF**, place the **OFF/Reset** switch (Figure 3) in the manual position to start the engine.
2. Verify **Warning Lamp** on the control panel comes **ON** (lit) for 3 seconds while the engine is cranking.
3. After 3 seconds verify that **Warning Lamp** is **OFF**.
4. Place the **OFF/Reset** switch back to the **OFF** position to shut down the engine.
