ANGLE BRACKET MODIFICATION

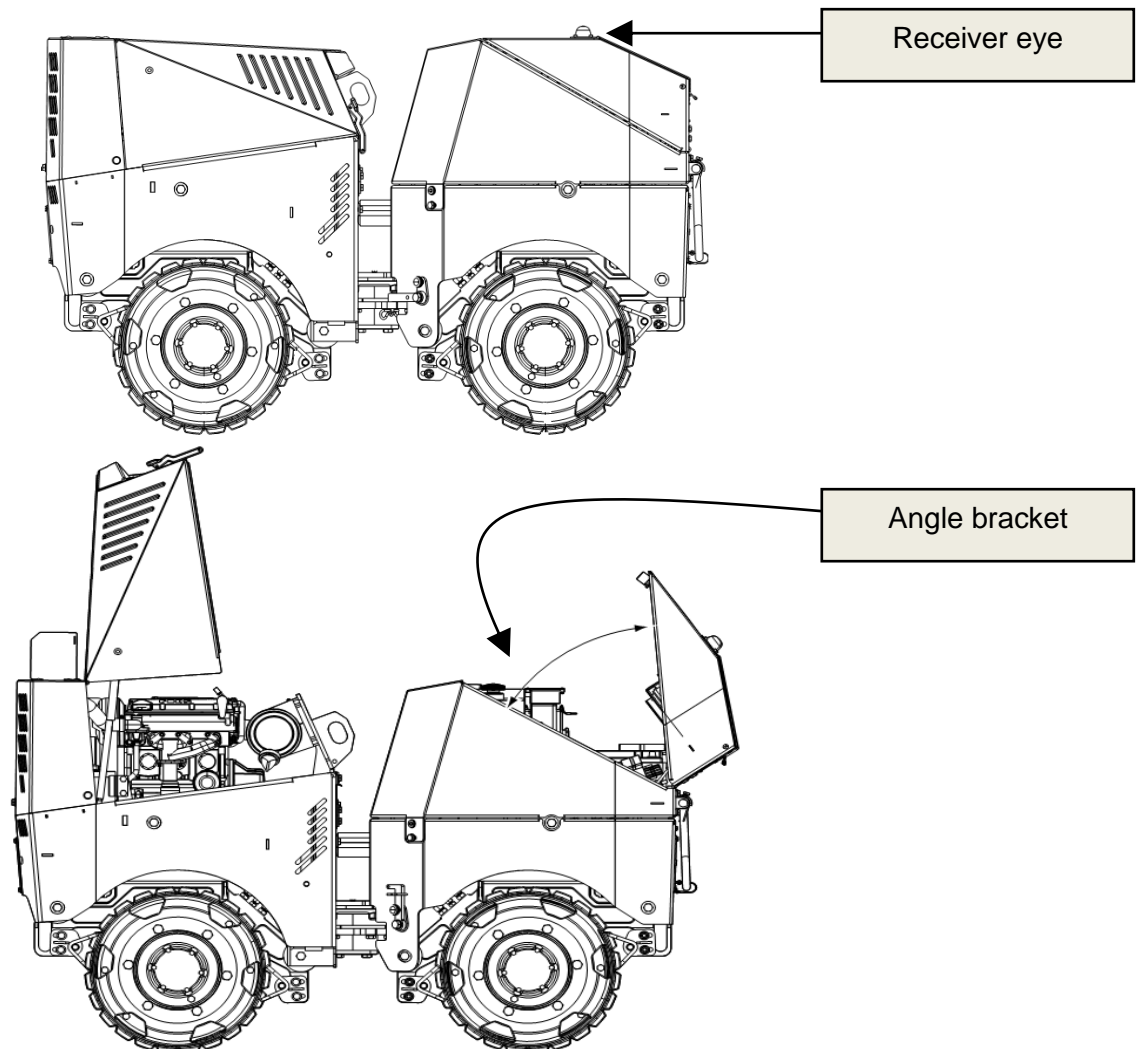
This information is provided as a pre-caution, as this note was taken when a machine became accidentally hit, causing the top cover to shift in result; damaging the receiver eye. Trimming the angle bracket will provide more clearance to the receiver eye.

The receiver eye is mounted to the top cover and is located just above the angle bracket.

It has been noted as a pre-caution for the angle bracket to be trimmed.
