ECCENTRIC ASSEMBLY REPLACEMENT

Part Number 4-760280

This Technical Information document is intended to notify parts and service personnel of the new eccentric assembly. The complete assembly can be replaced as an option instead of performing a more involved repair of the individual parts of the assembly. This document is also a notification of this new part number as it's not found in the parts manuals.

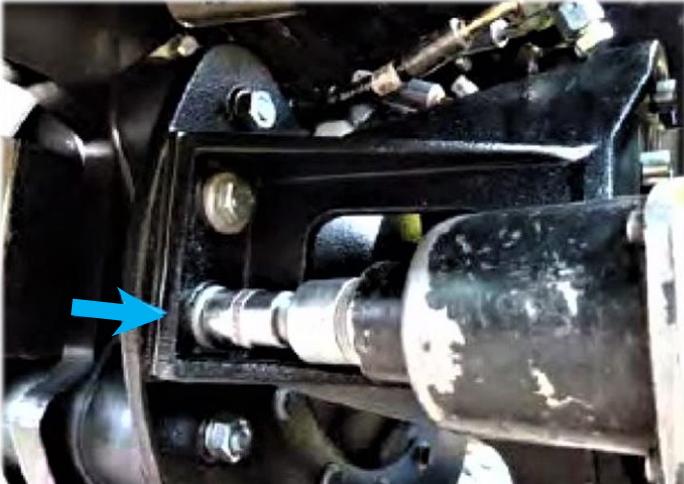
Blue Arrow – Six M12 drive motor flange (85 Nm)

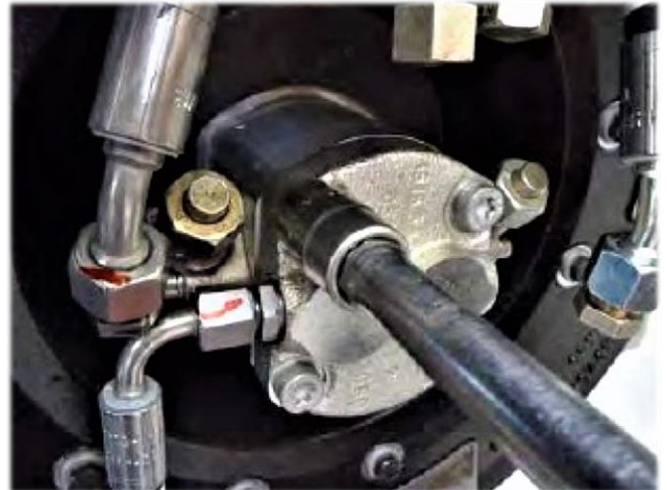
Two M10 bolts to mount the vibration motor (56 Nm)

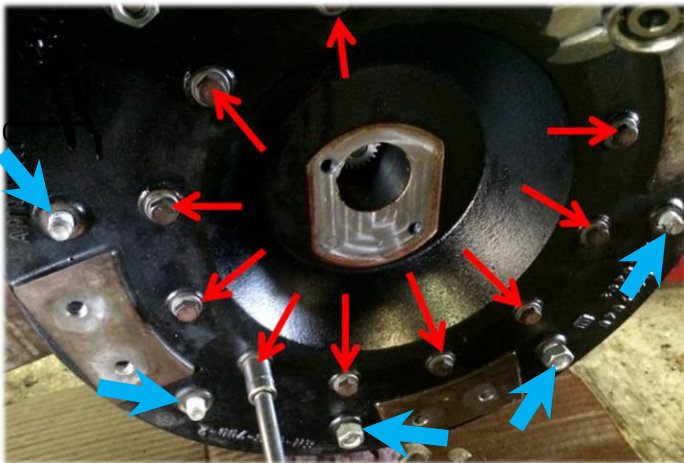
Blue Arrows – M12 eccentric cover bolts to shock isolators (50 NM)

Red Arrows – M10 eccentric cover bolts are sealing area (36 Nm)

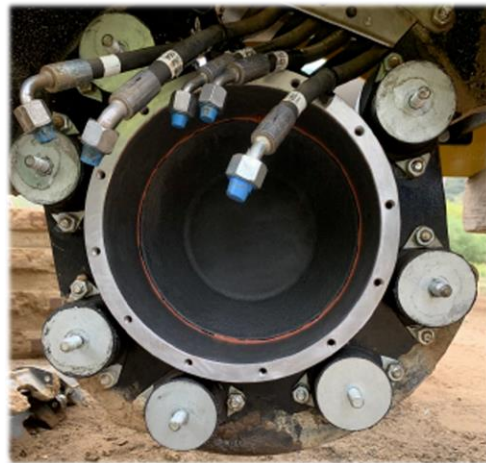
All exciter weights and bearings will come off with cover (heavy). Remove old grease from inside empty cavity.
