ECU845 UNREADABLE SCREEN, CONTRAST ADJUSTMENT AND FIRMWARE UPDATE

APPLICABLE TO MODELS

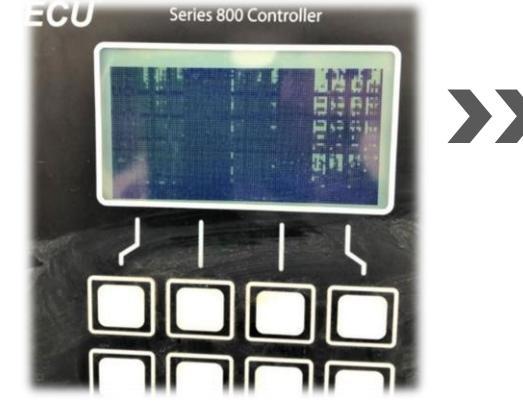
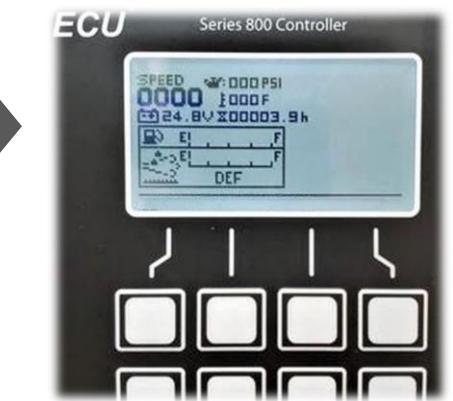
Some ECU845 controllers may present with a partially unreadable display screen due to exposure to extreme weather condition. Most of these occurrences can be resolved by making a Display Contrast Adjustment in the controller settings. In situations that this doesn't correct the problem or other display distortions are present, reference page 2 of 2 to proceed with the firmware update process then contact the MQ Power Technical Support Department at 800-835-2551 or at mqptechsupport@multiquip.com to request the newest firmware for your controller.

- 1) Put the unit controller in Diagnostic mode:
 - Press and hold the hour meter button while placing the Auto-OFF manual switch into Manual
 - Release the hour meter button after a few seconds
- 2) Contrast Display Adjustment:
 - a) Depress the "Program/Exit" button to continue
 - b) Scroll to "USER LOGIN" by depressing the "DOWN" button
 - c) Depress the "SELECT" button to continue
 - d) SELECT "ENTER LOGIN"
 - e) Enter the service password (75057) by navigating with buttons <<< & >>> and depressing the "SELECT" button to make character selections
 - f) After entering the password, depress the "BACK" button to continue and then select "SAVE"
 - g) Scroll to "ADVANCED OPTIONS" menu and select "DISPLAY CONTRAST"
 - h) In "DISPLAY CONTRAST", change the "VALUE" to "0" and select "SAVE"
 - i) The settings change is completed
