NEUTRAL JUMPER CONNECTOR

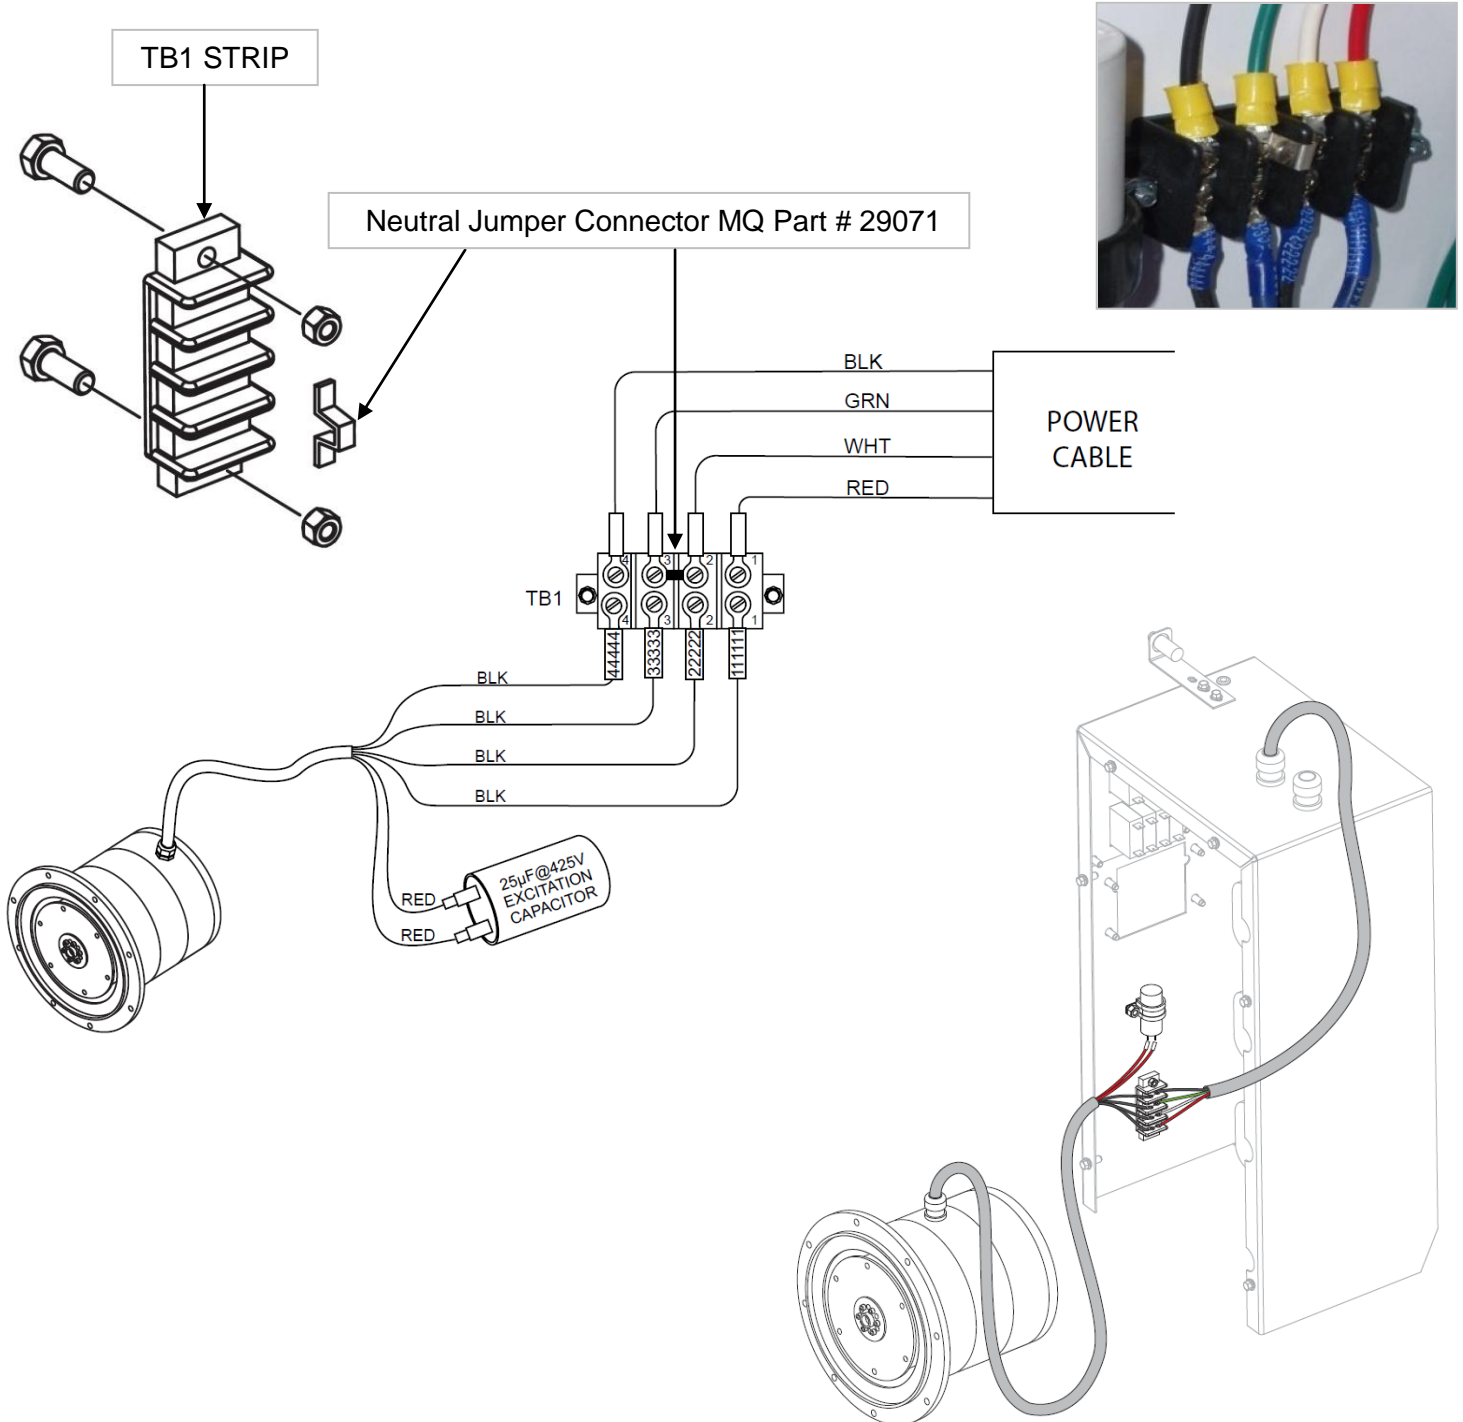
Several occasions have been noted where only two of the four lamps come on after performing a gen-end conversion or replacement. The cause in these cases was found to be from a Neutral Jumper Connector being left out from the TB1 strip during reassembly. The jumper connector completes the Neutral connection.
