**Service Bulletin No.** RT20050520 Rev A  
**Subject:** Incorrect Choke Decal  
**Model:** MT74FA and MT84FA  
**Product Group:** RT  
**Date:** 05/20/2005

**SERVICE BULLETIN**

Choke Decal

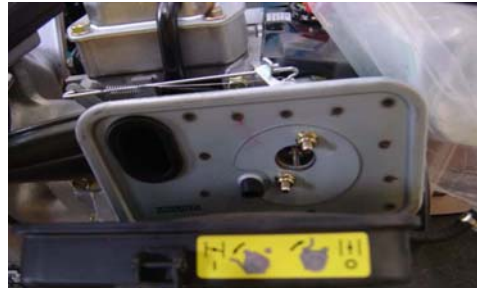
The MT74FA and MT84FA Rammers have an incorrect decal which is used to show the setting for the choke (the choke decal is pointing in the wrong direction). The correct setting is the opposite of what is shown on the decal. Please contact Multiquip to obtain the correct decal (Part No. 0732004430) needed to replace the original decal.

1) Remove the original incorrect decal.
