Informational Bulletin No. VR20080610
Subject: Transport Bracket
Model: P33/24 HHM/FCR
Product Group: Vibratory Rollers
Date: 06/10/08

Rammax Vibratory Roller Transport Bracket

Machines Affected:
ALL P33/24 HHM/FCR

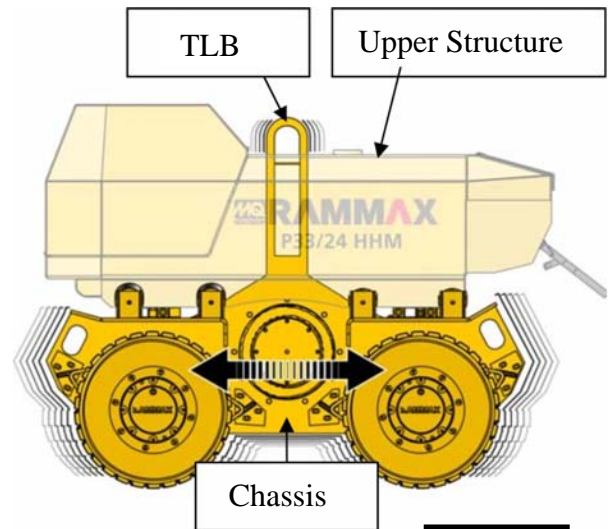
Figure 1

The transport bracket (TLB) required for lifting or transport must be able to vibrate freely at all times during operation of the machine (Figure 1).

Any lifting gear used for transport must be immediately removed on completion of the transport/lift operation. Lifting gear of any kind remaining attached results in frame or transport bracket damage.

REMEDY: The lifting bracket should be used exclusively for transportation or placement of the machine at the work site and should never be used to tether the machine during operation. The lifting bracket must be able to vibrate freely at all times while the machine is in operation. Always remove all lifting equipment (ropes, chains, hooks, cables) from the machine while it is in operation.

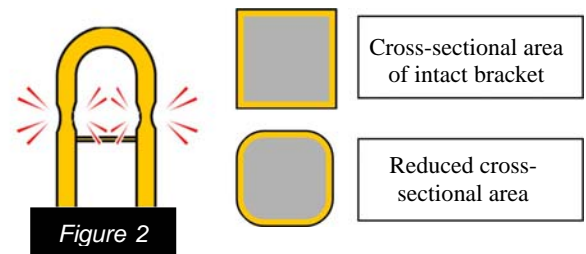
Figure 2

If any lifting gear is left attached to the transport bracket during operation of the machine, it will constantly vibrate against the transport bracket. Material will thereby be worn away, thus decreasing the load limit by reducing the material cross-section (Figure 2).

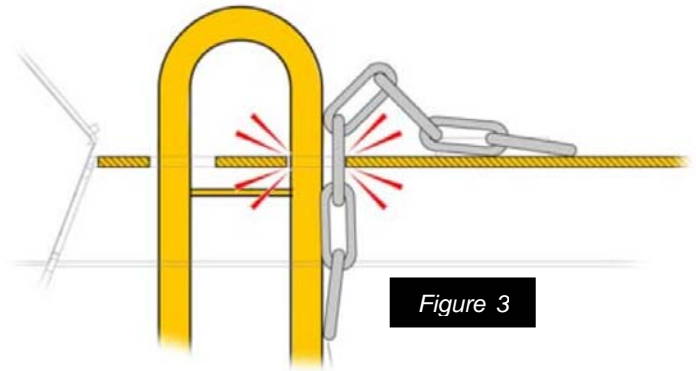
Figure 3

The area underneath the transport bracket is protected against the ingress of foreign matter and dirt by a foam insert. Lifting gear attached to the machine can damage the foam insert. As a result, lifting gear (chains, ropes) can be trapped between transport bracket and upper structure (Figure 3). If the bracket can no longer vibrate freely together with the chassis due to the trapped lifting gear, it will result in material fatigue at the weld seam (Figure 4) and adds strain to the components. This can lead to cracking of the transport bracket and in the mounting frame of the chassis around the flyweight housing (Figure 5).
