STUB SHAFT REMOVAL

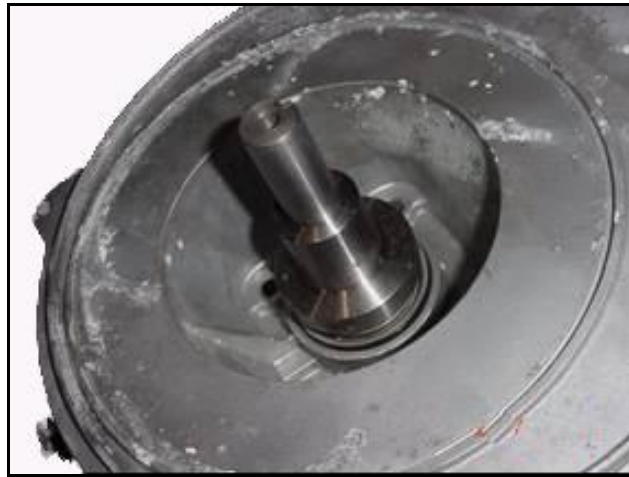
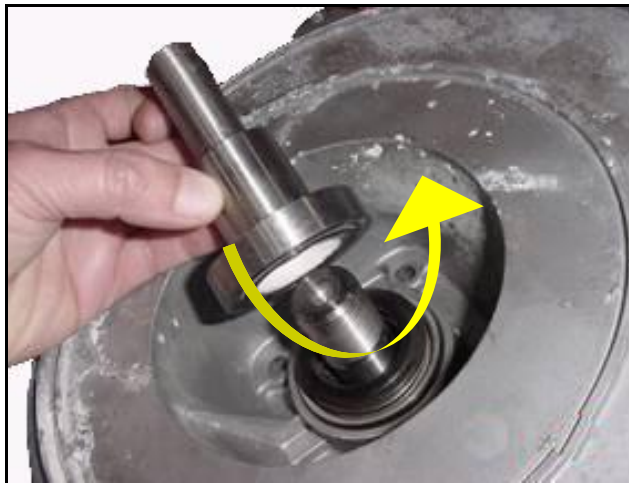
Removal of inner impeller casing cover exposes pump stub shaft, the pump stub shaft is threaded to engine crank, right hand threads.
