MULTIQUIP ENGINE-DRIVEN HIGH PRESSURE CENTRIFUGAL PUMPS WILL NOT PRIME AND/OR DISCHARGE WATER

Technical Information

Product Group: DEWATERING Model: 1.5", 2", 3" & 4" HIGH PRESSURE PUMPS

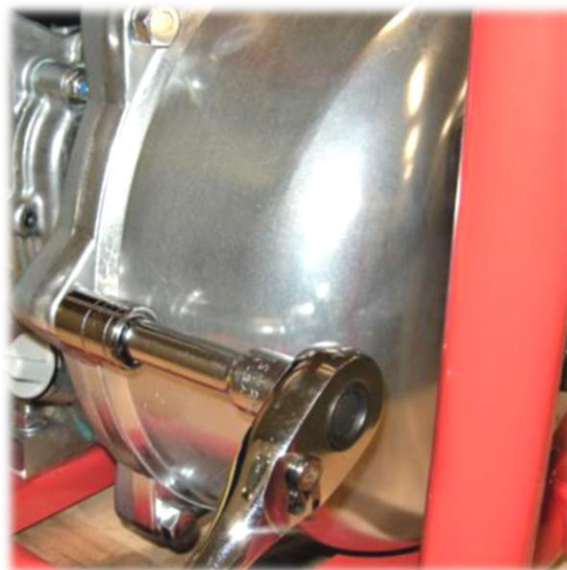
Figure 2.

1. Turn the engine to OFF. & let the unit cool down.
2. Remove the 'red' Casing Drain Plug and let the water out.
3. Remove the front cover to inspect the volute & impeller assembly: [Figure 2]
4. Check the surface integrity of the Impeller and Volute assemblies [Figure 3 & Figure 4]:
 - All parts clear of debris that might have may lodged against the surfaces or have clogged the openings to the fully closed impeller(s).
 - Check that there is no damage to the impeller(s).
