Model: HHXDF5, HHNG5, HTXG6DF, STXDF,

JWN24HTCSL, LD6, LD6SL

Trowels used for Polishing Applications

This document addresses service and maintenance concerns for ride-on trowels used in floor polishing applications.

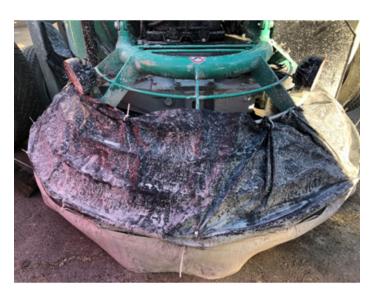
Plastic added to the outside of the guard rings to keep slurry from splashing onto works and nearby walls or columns. All the splash is being contained back into the trowel components.

- Consider adding covers or shielding to deflect slurry from moving parts.
- Do not use any type of form oil as this could contaminate components

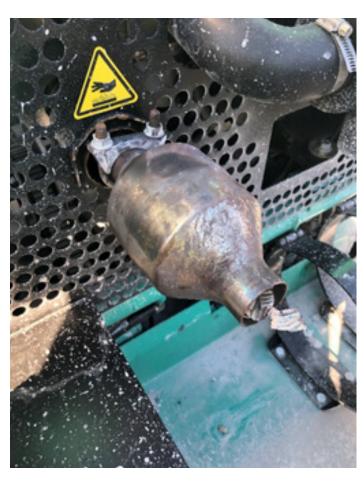
Shown is a customer added clean emissions Exhaust Catalyst. Trowel model HHXDF5 is OEM equipped from Kubota with a EPA approved catalyst internal to the existing muffler. Adding any type of catalyst or air scrubber is prohibited and may void the warranty provided by the engine manufacturer.

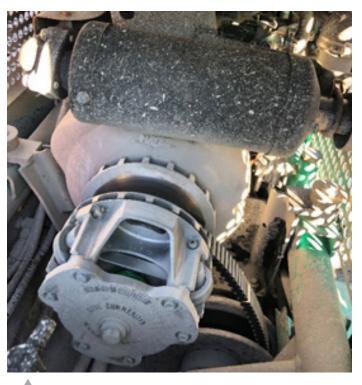
Both photos show slurry splash onto the upper clutch area. Once allowed to harden the clutch movable components will be limited and not operate correctly.

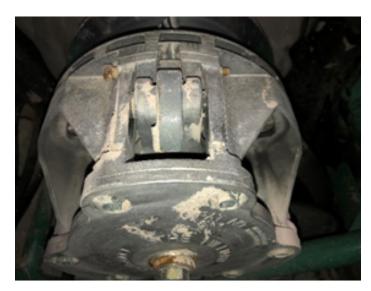
Shown is concrete slurry splashed into the lower pulley, limiting it from closing and its overall operation. Drive performance will be lost and belt slippage resulting in belt damage will occur.

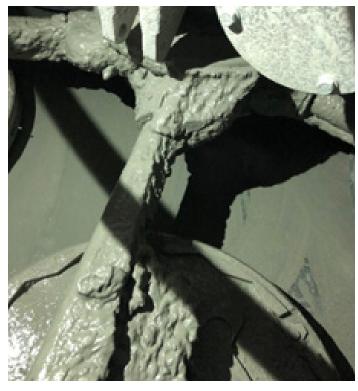
Heavy slurry build up on arms and pitch bolt area also add weight to the unit. When rotating this makes for an out of balanced rotation resulting in damaging vibrations.

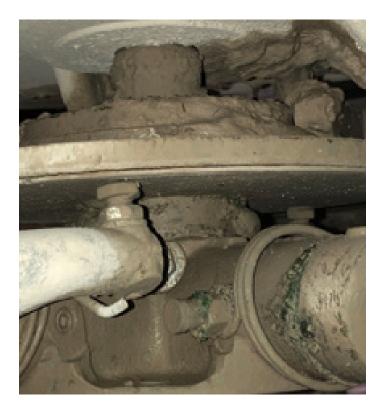
Heavy slurry built up on the spider and thrust plate area. Bearing and bushing failure will occur as well as potential for the gearbox output shaft seal to be damaged.

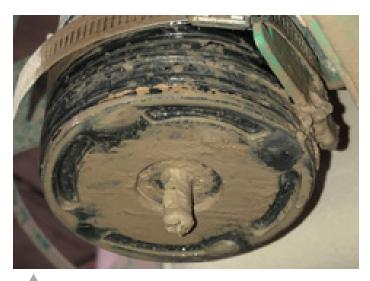
Shown is the charcoal canister that is part of the gasoline evaporative emission system. The lower air intake port in both photos are restricted or fully plugged with slurry. If the unit was switched from LPG

fuel to gasoline, engine operation will be

affected.

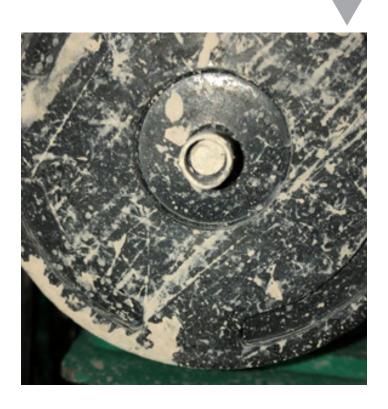
Slurry build up on hydraulic components may reduce cooling and increase chance of contamination during servicing.

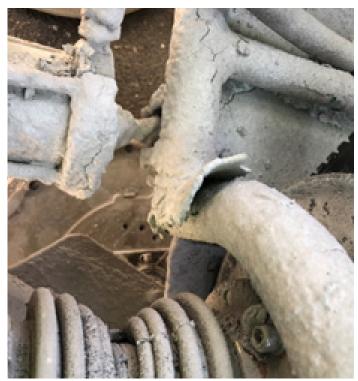
Slurry build up on frame and steering cylinder.
