## VACUUM PUMP WIRING COUNTERMEASURE

# Technical Information

Product Group: GENERATORS

Model: DCA125SSIU4F

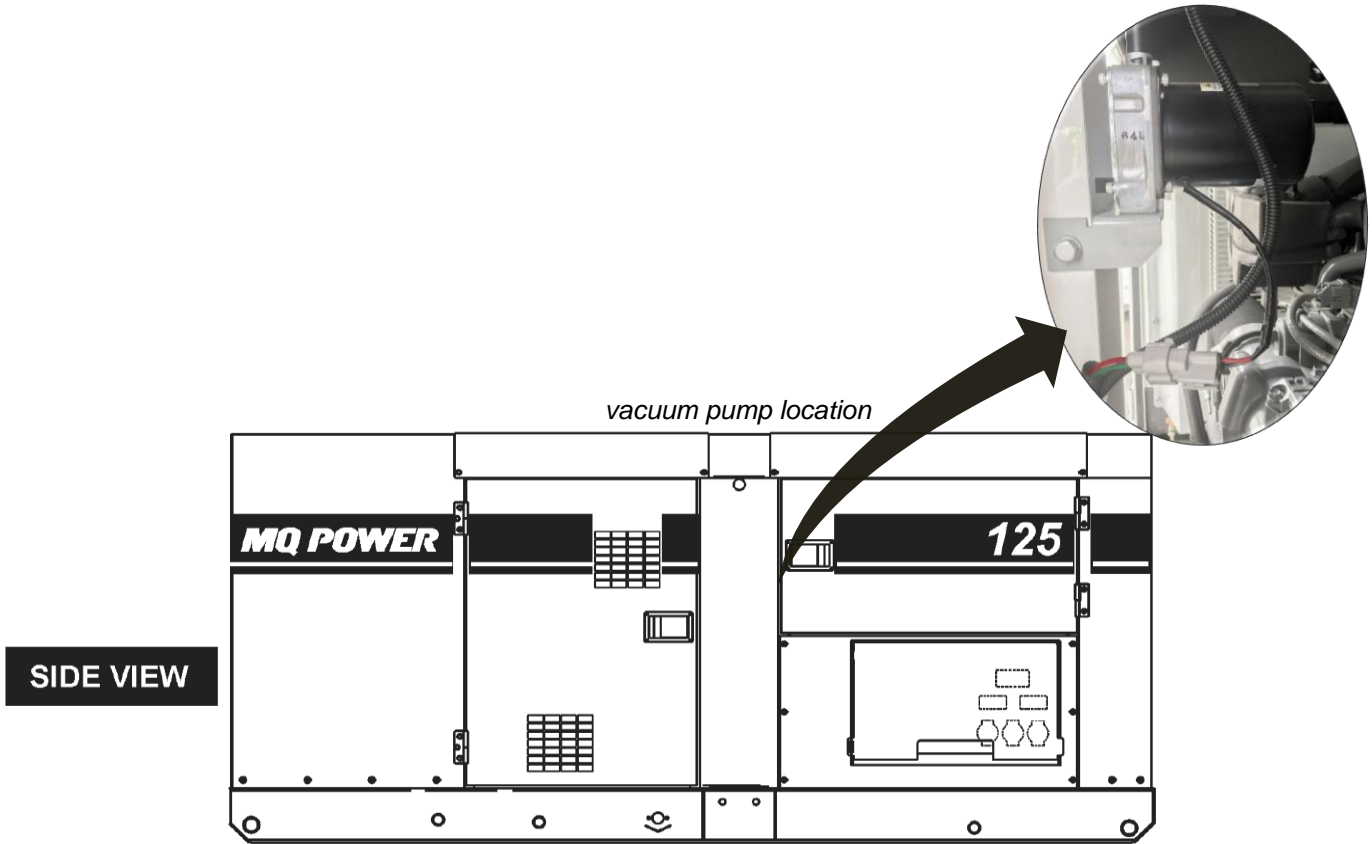
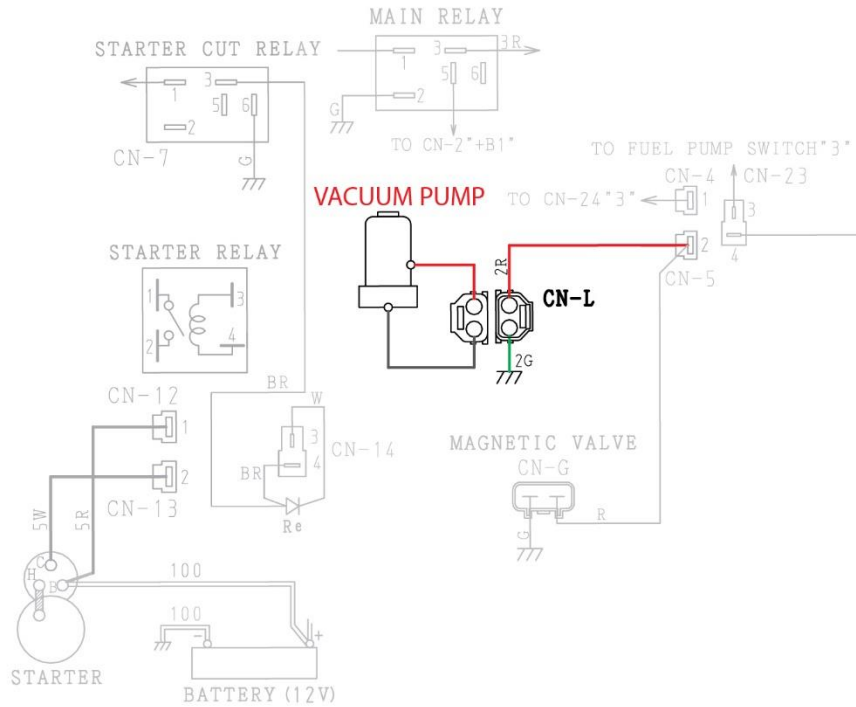
It has been noted that the vacuum pump may have the wires crossed on the wire connector and may need to be swapped (corrected). Failure symptoms observed in this case could be a DTC SP10029 FMI 0 or Isuzu P-code P2468, for Excessive Purge Time-Out. Due to the incorrect wiring, the exhaust throttle valve may not function correctly during a SCR purge cycle. Inspect engine harness connector CN-L.

This one is wired incorrectly

1. Locate the vacuum pump connector CN-L on the engine wiring harness. If it is wired as in the picture the wires are installed backwards.
