EXCITER VENT OIL CONTAMINATION

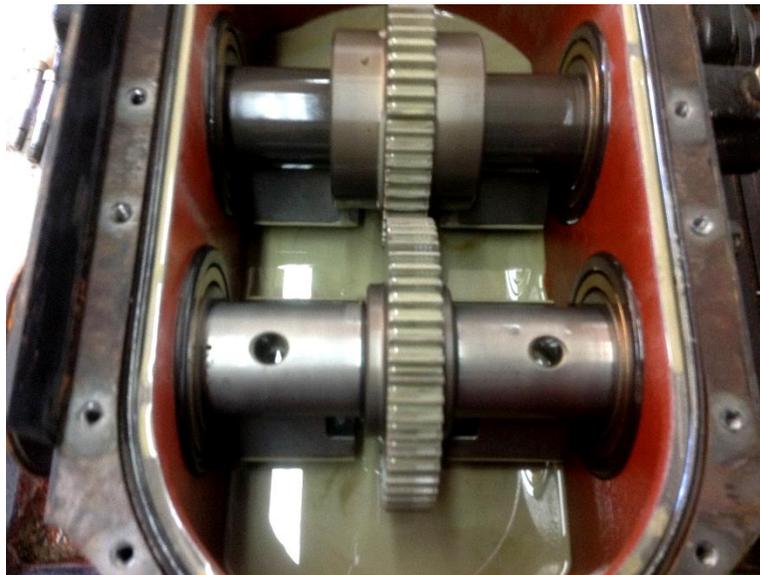
When the plate compactor is turned off and the temperature begins to drop in the eccentric assembly, this will cause outside air to be drawn back into the eccentric case. Generally this is not a problem, however, in cases where the plate is left in a trench that has water in it, the water can be drawn into the eccentric assembly. As the water cools down the exciter case, this cools and reduces the air pressure inside. If the water reaches the level of the vent hole, water can be drawn into the case.

The water then has contaminated the case, the lubrication oil, bearings and shafts. This will oxidize the metal parts preventing them from smooth operation and often binding them from proper movement, which will affect the plates forward and reverse direction travel. Water observed in the eccentric case when oil is changed should be noted in service records. The damage to exciter parts may not be immediately observed in operation.

Prevention: Always remove plate compactors from low level trenches or other areas if water can begin to rise and flood the compactor. Following service intervals to check and change eccentric oil can reduce contamination. Increase oil changes in areas that are higher in humidity that brings water into the case.
