SPIDER PLATE IMPROVEMENT

HTXD6i & STXD6i models with six blade spider

MQ Part # 23341 (spider assembly)

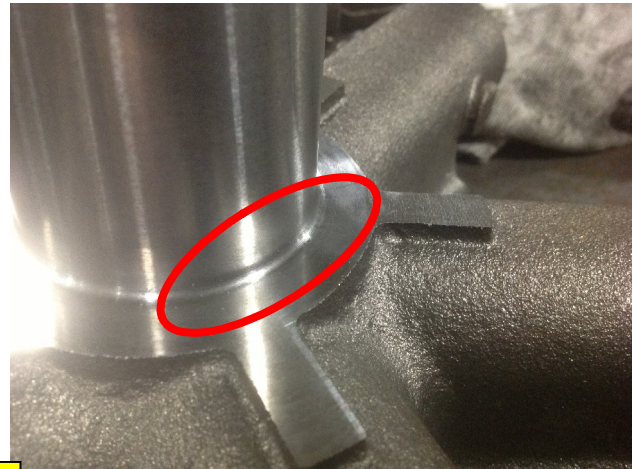
This photo shows the
OLD RADIUS cut.

A change was made to the spider plate to strengthen the area shown below

Production change begins with serial # **1204**

- *The radius cut where the spider hub meets the spider legs has increased to 3/16"*
- *Spider serial numbers are stamped into the top of the spider hub.*

NOTE: The spider is shown without the sleeve installed on purpose, to allow the radius to be shown for this document. The serial number can be used to determine if the spider has the new radius cut.

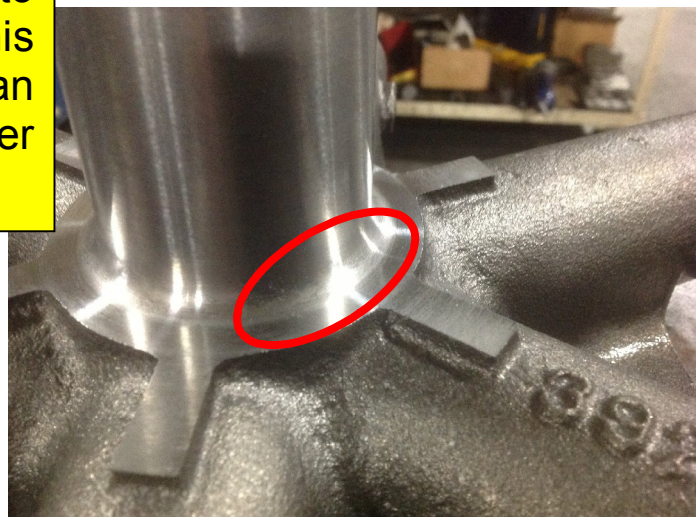
This photo shows the
NEW RADIUS cut.
