Service Bulletin No. CP20060224
Subject: Control Box Voltage Spike
Model: LS40D, LS40TD, LS50TD & LS60TD
Product Group: Concrete Pump
Date: February 24, 2006

LS40D, LS40TD, LS50TD and LS60TD Concrete Pumps

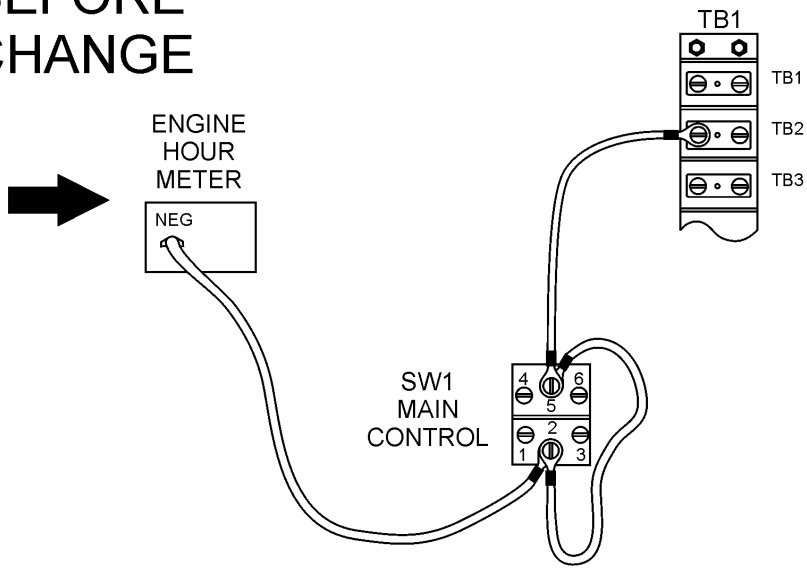
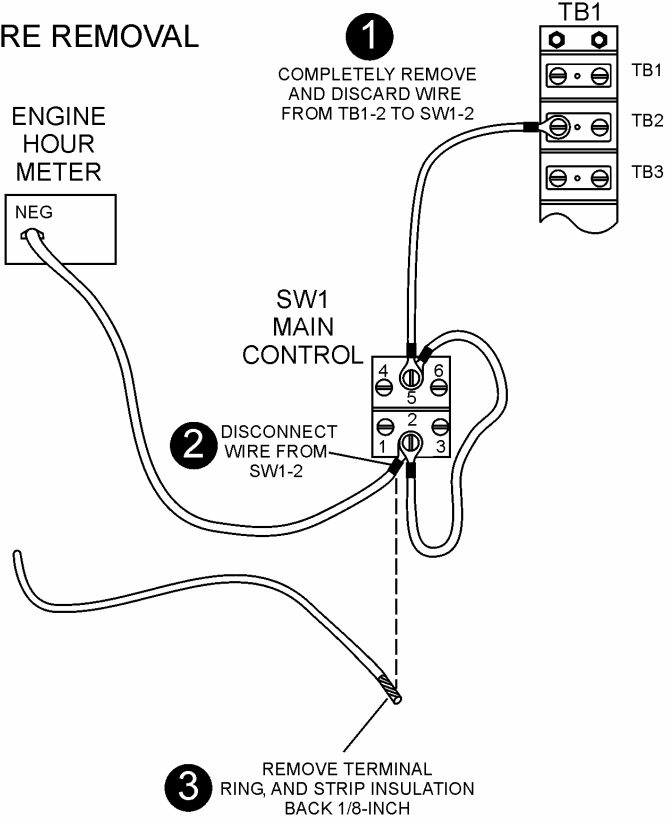
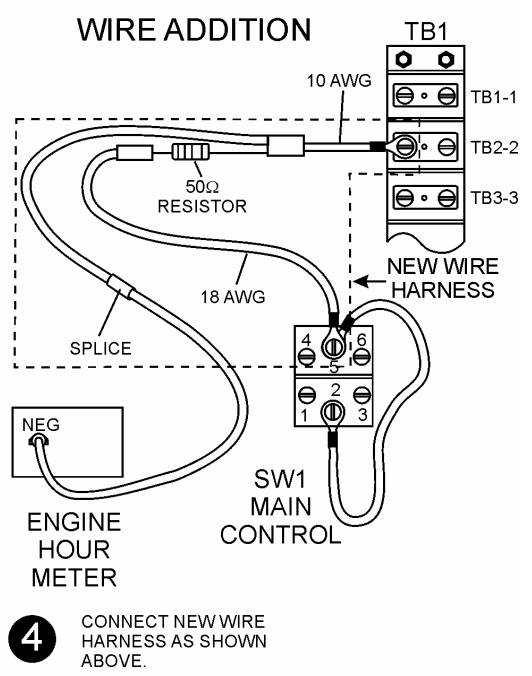
Figure 1 Wiring Diagram

- It has been discovered that negative ground spikes are backfeeding through the electrical system into the potted interior control box. These spikes are harmful and destructive to the sensitive integrated circuits within the potted control box.

BEFORE CHANGE

WIRE REMOVAL

WIRE ADDITION

AFTER CHANGE

- To eliminate these harmful ground spikes, a 50 ohm resistor has been added to the control circuitry. The addition of this resistor will eliminate the ground spike condition that currently exists.

Wiring Removal/Modification (Reference Figure 1)

1. Remove the wire connected between TB1-2 and SW1-5. Discard wire, it will not be used anymore.
2. Disconnect the wire connected to the **NEGATIVE** side of the engine hour meter from SW1-2 (Main Control Switch).
3. Using wire cutters, cut the terminal ring from the wire disconnected in step 2 and strip the insulation back 1/8-inch.
4. Using the supplied new wiring harness connect the terminal ring with the larger wire (10 AWG) to TB1-2.
5. Connect the terminal ring with the smaller wire (18 AWG) to SW1-5.
6. Splice the remaining wire (strip insulation 1/8-inch) from the new wiring harness to the wire coming from the **NEGATIVE** side of the engine hour meter.
7. Place the front cover back onto the control box and secure using 2 phillips head screws.
8. Reconnect the negative battery cable to the battery.
