SPRING CYLINDER DESIGN CHANGE

As part of Multiquip's commitment to continuous product improvement the guide cylinder design of the MTX60 was recently changed. A machined taper was removed to increase cylinder thickness and improve component durability.

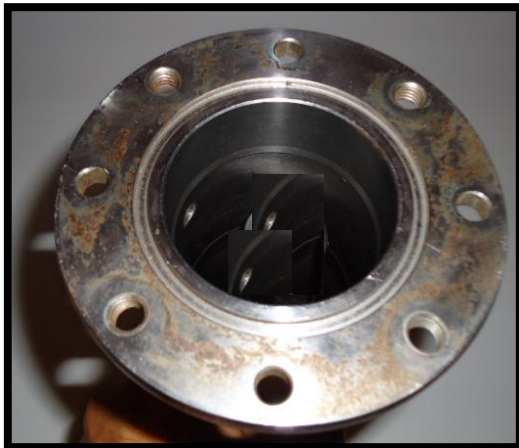
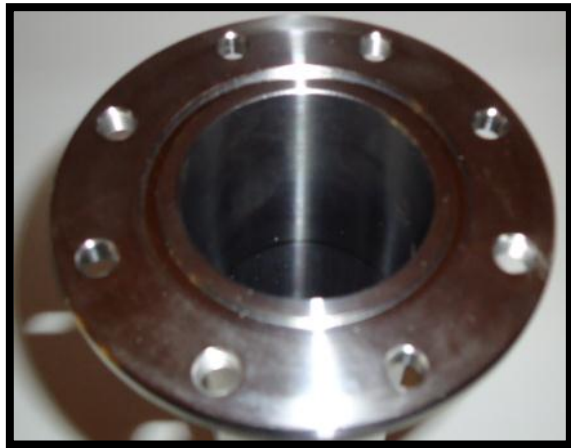
Externally, the spring cylinders will appear the same. To visually distinguish the two designs inspect the inside of the cylinder walls. A machined taper will be visible along the inside diameter of the discontinued cylinder. The new design, which does not use the taper, has a smooth surface inside the cylinder.

ITEM#	DISCONTINUED P/N	DESCRIPTION	NEW P/N
12*	368347280	Spring Cylinder, MTX60	368347281

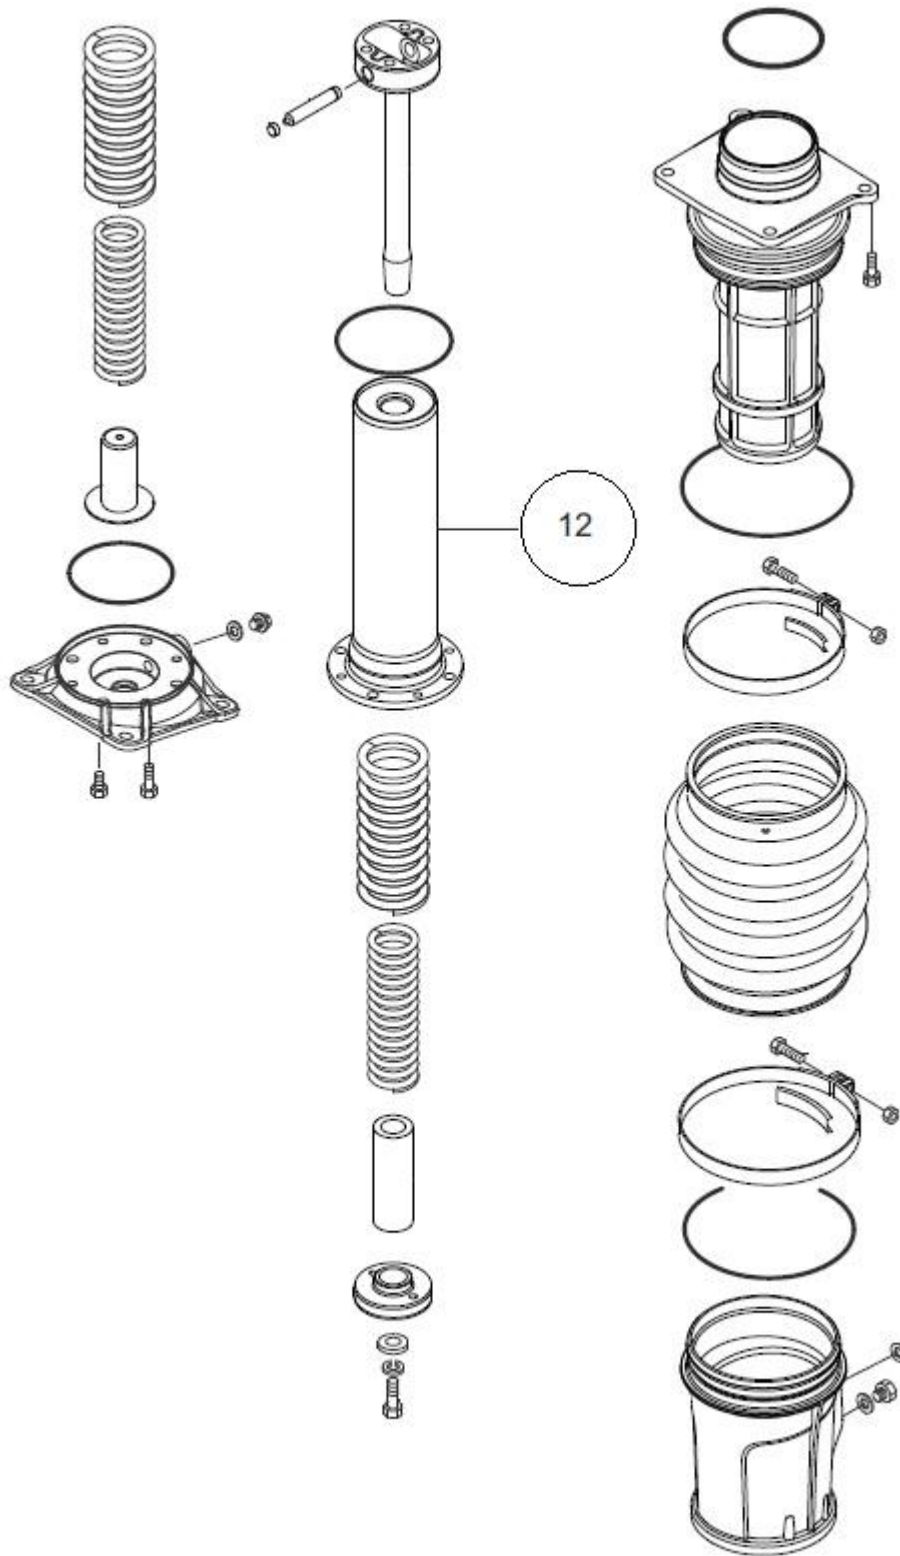
**Reference Guide Cylinder Assembly in MTX60 parts manual on following page*
